Manhole Inspection Summary

Manhole # S1500_013MH

Location Address: **3032 TIOGA PKWY**

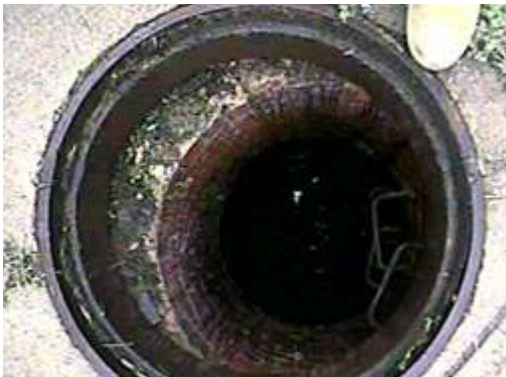
Top View

Frame Offset: **5** (in.) Condition: ☒ Sound ☐ Cracked ☐ Leaks

FRAME OFFSET

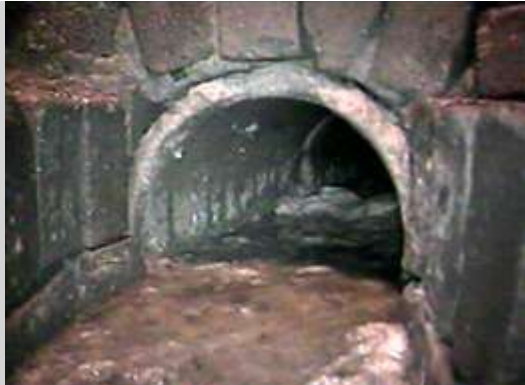
12 O'Clock Outflow

8 in. Circular Gravity Sewer
Pipe Out @ 12 O'Clock

Pipe Height: (in.) Direct
Pipe Material: **Clay** ☐ Pipe Lined
Invert Depth: **9.78** (ft.) Flow Characteristics: **Slow**
Deposits: ☐ None ☐ Mud ☒ **Sludge** ☒ **Debris** ☐ Grease
Silt Depth: **2** (in.) Deposits Extent: **Light**
Infiltration: **None** Pipe Seal Cond: **Sound**

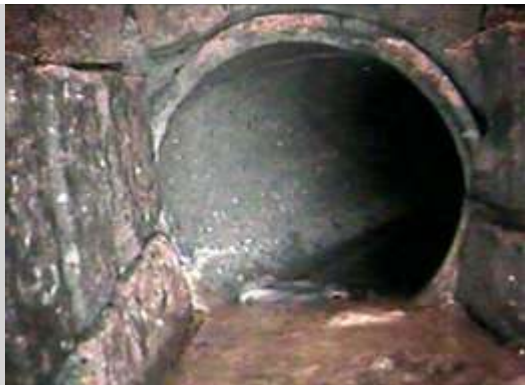
7 O'Clock Inflow

8 in. Circular Gravity Sewer
Pipe In @ 7 O'Clock

Pipe Height: (in.) Direct
Pipe Material: **Clay** ☐ Pipe Lined
Invert Depth: **9.72** (ft.) Flow Characteristics: **Slow**
Deposits: ☐ None ☐ Mud ☐ Sludge ☒ **Debris** ☐ Grease
Silt Depth: **0.5** (in.) Deposits Extent: **Light**
Infiltration: **None** Pipe Seal Cond: **Sound**
